MEMORANDUM

Re: Post-TCRA Quarterly Inspection Report - January 2013 Inspection

This document reports the results of the January 2013 quarterly inspection of the armored cap cover, fencing, and signage installed for the Time Critical Removal Action (TCRA) at the San Jacinto River Waste Pits Superfund Site (TCRA Site).

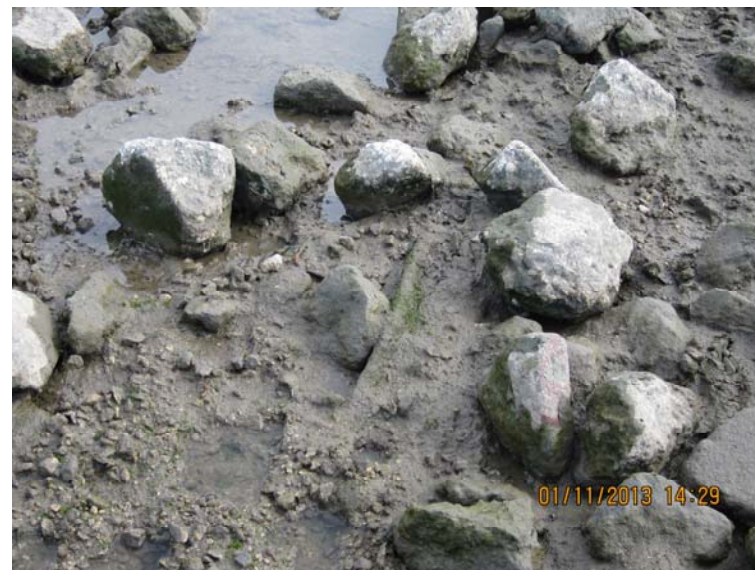
There was a low tide during the January 11, 2013 visual inspection because of northerly winds. This low tide exposed two localized areas of the TCRA armored cap cover with less than 12 inches of stone cover thickness. The underlying geotextile layer in those areas was intact and there was no evidence that any of the underlying materials were or had been exposed. The USEPA was notified of this condition through a phone conversation and submission of a notification letter on Tuesday, January 15, 2013. The Respondents conducted a field investigation during a low-tide event on Thursday, January 17, 2013 collecting topographic and probing data that identified three additional areas that had less than 12 inches of stone cover thickness and would require maintenance. One of the three additional areas also required geotextile placement over an approximate 2 foot by 2 foot area. Further phone communications with the USEPA took place on Thursday, January 17, 2013, and an additional written notification was submitted to USEPA on January 18, 2013. The Respondents continued to evaluate the TCRA cap during the low tide conditions that existed on January 17 and January 18, 2013. The low tide event on Friday, January 18, 2013 was the lowest of any of the inspection days, and was at -2 foot mean sea level (MSL)³.

Photo 12: Thin armor cap area identified during visual inspection (view north)

The areas in the Eastern Cell were characterized by reduced stone cover thickness or other conditions, as described in the TCRA Inspection Repair Report. While the maintenance work was being performed, one small area required some geotextile repair. The TCRA Site fencing deficiencies identified along the western bank of the San Jacinto River consisted of cut chain link and bent/mangled bottom sections. All maintenance activities for the TCRA armor stone layer and repair activities for the deficient areas of TCRA Site security fencing have been completed. These activities are detailed in the attached Maintenance Completion Report (Appendix B).

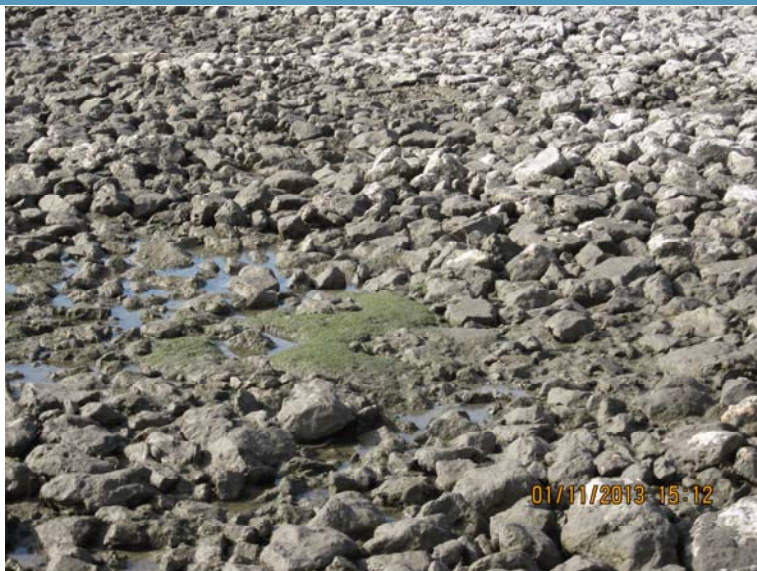
Photo 17: Background location from Photo 16 of thin armor cap area and exposed geotextile identified during visual inspection (view southwest)

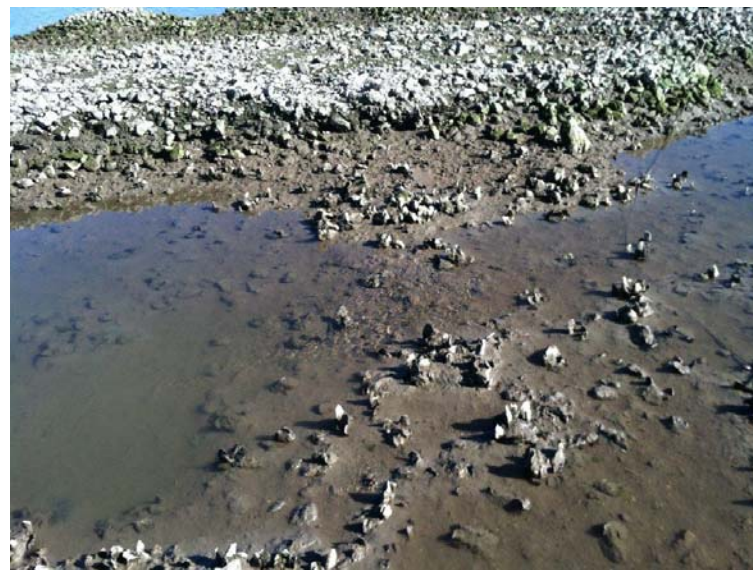
Photo 24: Area of Eastern Cell showing biologic growth and sediment deposition (view northeast)

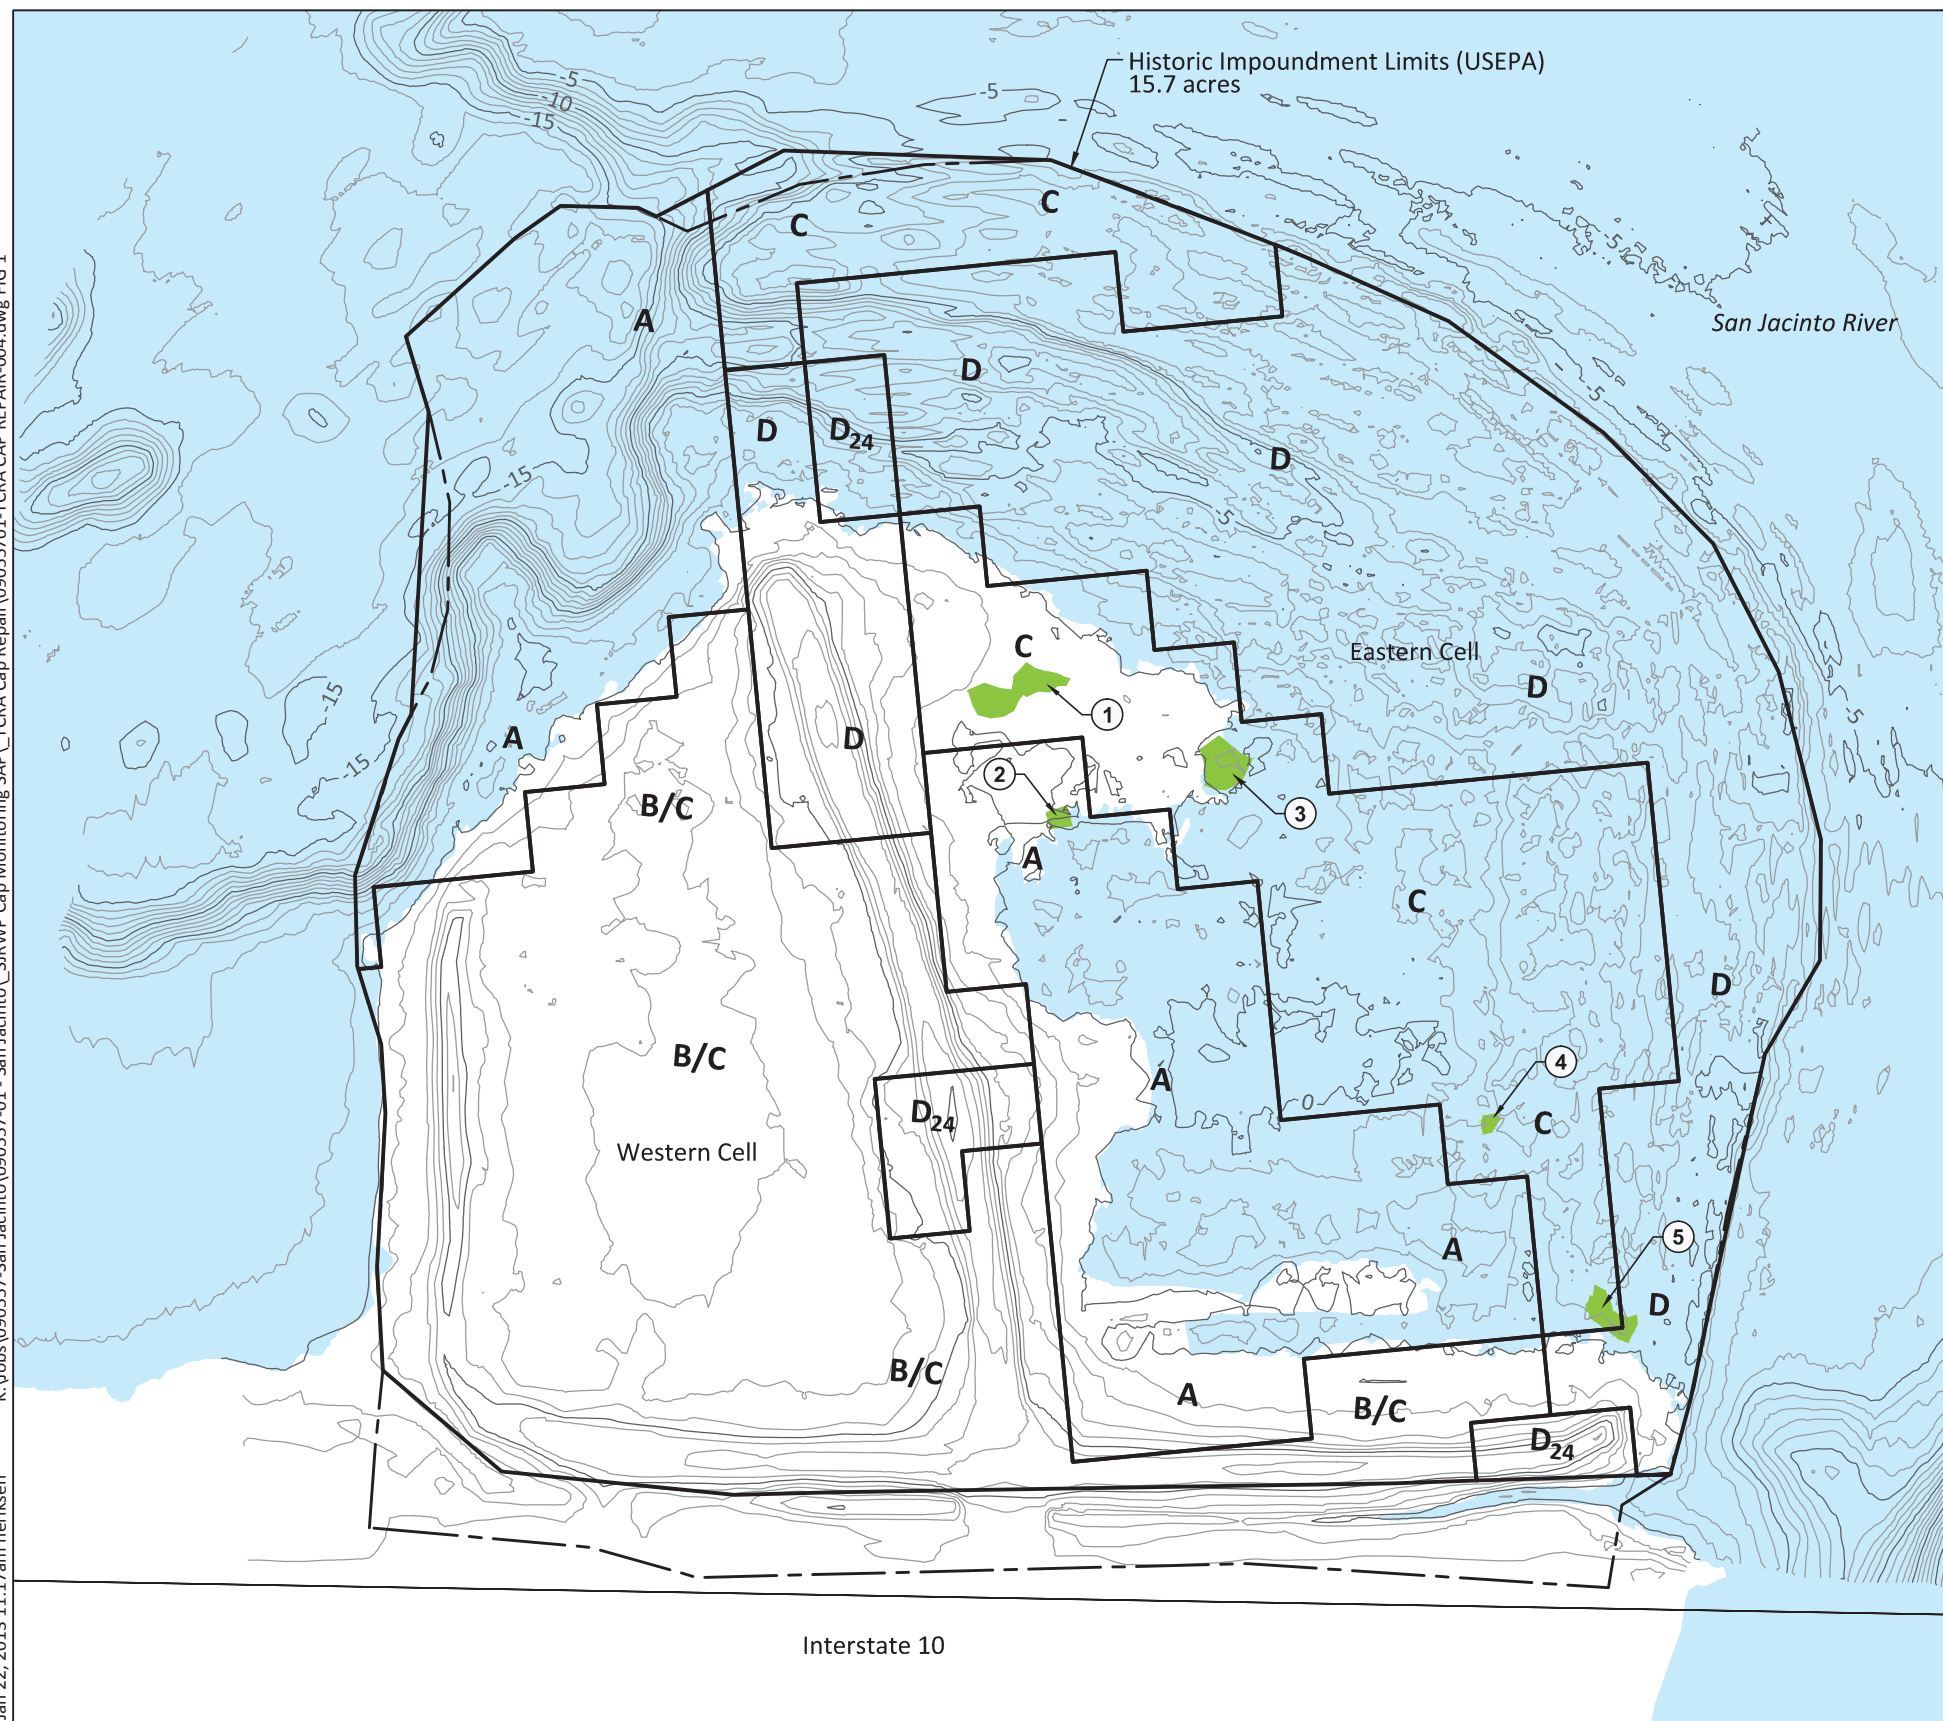
Wind and tides conditions over the last two days have been very favorable for a detailed visual inspection and surveying of the surface of the cap over large parts of the eastern cell that are normally submerged. That detailed visual inspection and surveying resulted in the discovery of additional areas that will require maintenance, and we are continuing to survey and probe those areas today. One area in particular, constructed with Armor Rock A, and measuring approximately two feet by two feet, exhibits a slight depression. It appears that the geotextile underlayment in this area may no longer be present (visual observation is hindered by the presence of standing water), but manual probing confirms that a 12 to 18 inch layer of Armor Rock A cap material and sediment is present within the depression. We are continuing to evaluate that particular location.

For Maintenance Areas 1, 3, and 5, it is anticipated that the armor material will be placed from land access points using a small loader (Bobcat, Skid Steer or equivalent) equipment as appropriate, within the horizontal limits delineated for the maintenance activities. The contractor will use placement methods previously approved by USEPA in the RAWP to prevent damage to the geotextile. Depending on tides, the materials may be hand placed.

For Maintenance Area 4, depending on water levels at the time of repair, the armor stone may be placed from water access points using marine-based equipment including, but not limited to, material transport barges; barge-mounted long-reach excavators, and support boats.

1. Minimum thickness of cap must be at least 12 inches in Armor Cap A and Armor Cap C locations, and 18 inches in Armor Cap D locations.
2. Contractor shall use placement methods that do not damage existing geotextile. Any damage caused by contractor shall be repaired to the owner's satisfaction at no additional cost.
3. Contractor shall use low ground pressure construction equipment and shall minimize maneuvering on the cap surface. Contractor shall repair any visible surface disturbance that was caused by the contractor's operations.
4. Contractor staff operating on site shall be 40-hour HAZWOPER trained.
